## Tech Note 534

# 1784PKTX Hardware Compatibility Issue with DASABDHPlus

Topic#: 002271  
Created: March 2008

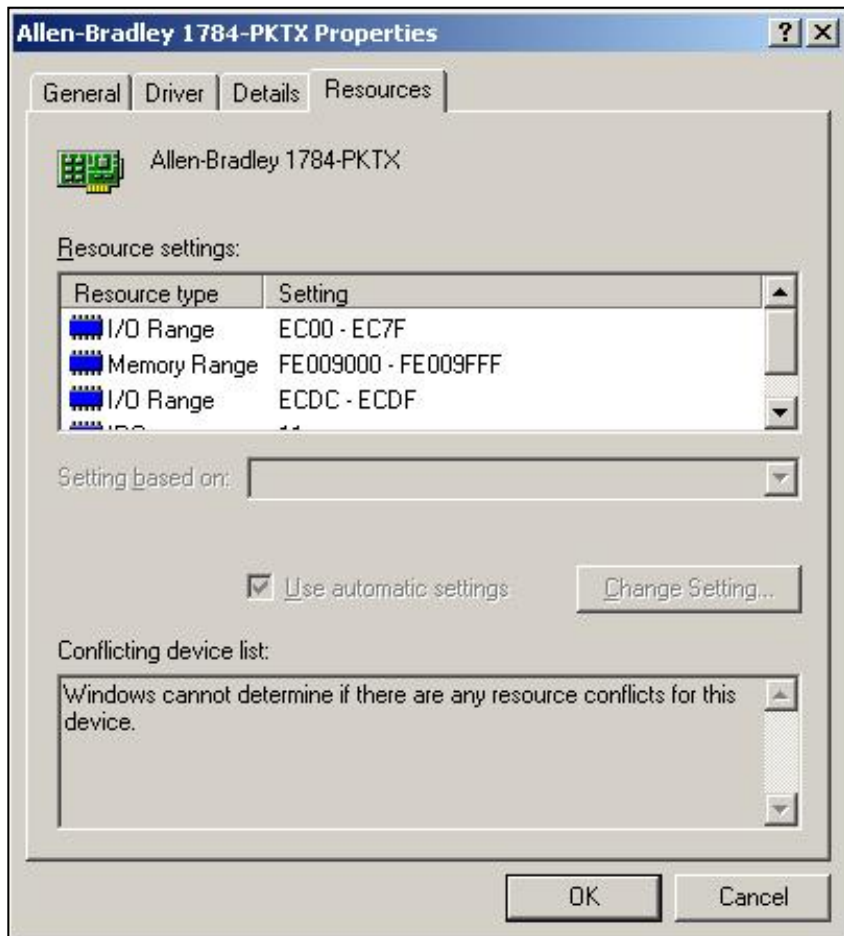
**Figure 1: System Resource Assigned to the PCI Card**

1. Make sure the jumper on the AB1784PKTX card are connected properly at 32 bit instead of 1M. The **CID = 0** position is selected if you have only one 1784PKTX card in this machine.
2. Make sure the DH+ (Blue Hose) cable is connected straight through the entire network (node to node). No cross over (the Blue and the Shield) should be used.
3. Use the Device Manager to locate the **1784PKTX** card. Check under the **Property/Resources** tab to see the Assignment. Resources must be assigned to this card, or it will not work.

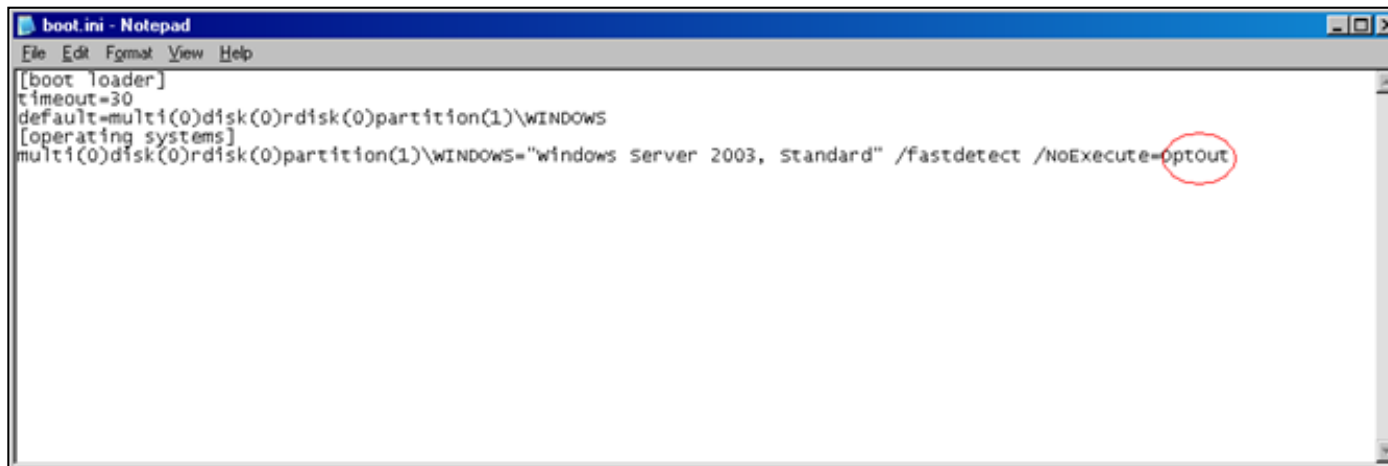
Figure 2: Change /NOExecute Parameter

This error is caused by the Windows XP Operating System or higher upgrade; MS no longer, by default, allows access to certain memory location which is used by or IO server.

The **KT dual port memory...not detected** error is sometimes resolved by making a minor change to the Windows boot. ini file – disabling the Data Execution Prevention (DEP). You should see a line in the **boot.ini** file with the parameter **/NOExecute**. By default, this parameter is set to **/NOExecute=optin**.

You must manually change the default setting in the **boot.ini** file to disable the Data Execution Prevention (DEP).

Please notice the partition number in the last line of code needs to match the partition number in the default line. And if the NoExecute is equal to **Optin** or **Optout**, you must change it to **AlwaysOff**.

To modify the boot.ini file, change this parameter to **/NoExecute=alwaysoff**.

Make sure that you only change the **/NOExecute** parameter.

- Reboot the PC then try communicating again. This modification is likely to resolve the **Dual port memory detected** error and establish good communication and data updates.

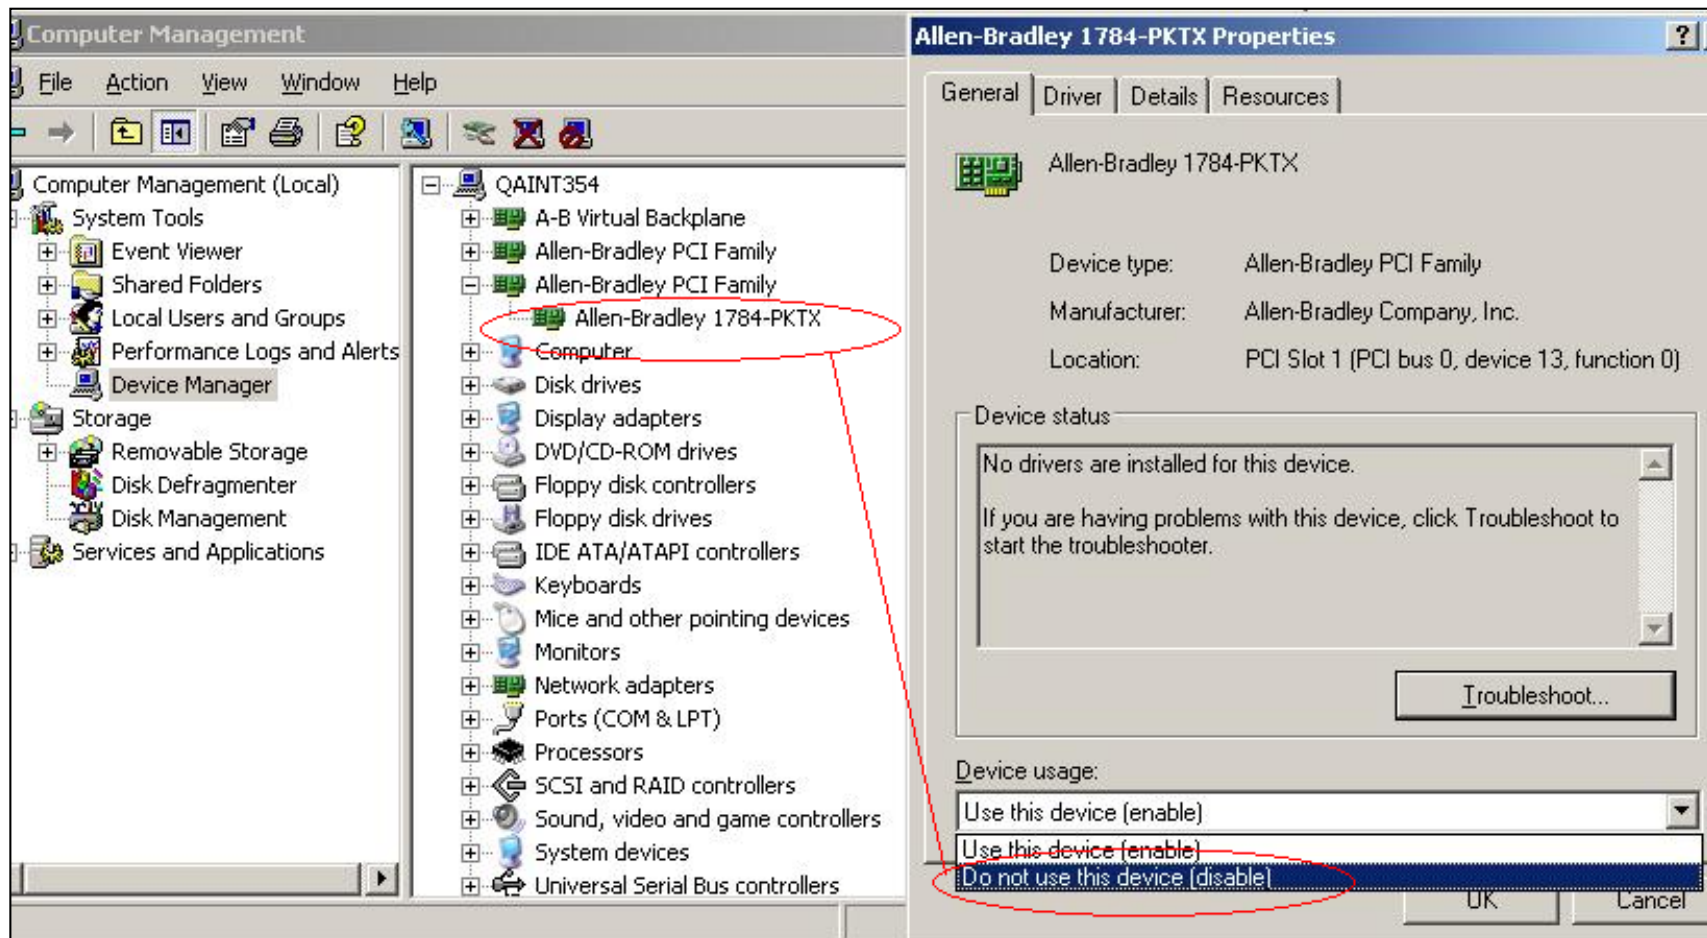
Figure 3: Device Manager Setting Do Not Use this Device (Disable)

If the **steps above** did not eliminate the **Dual Port Memory Not Detected...** error, complete the following steps to change the Device Usage setting for the PKTX1784 adapter.

1. Open the Properties dialog box for the Allen-Bradley 1784-PKTX Device.
2. Set the Device usage parameter in the **Properties/General** tab to **do not use this device** in the Device Manager.
3. Click **OK** and reboot your machine.

**You do *not* need to re-enable the Device Driver after you reboot.**

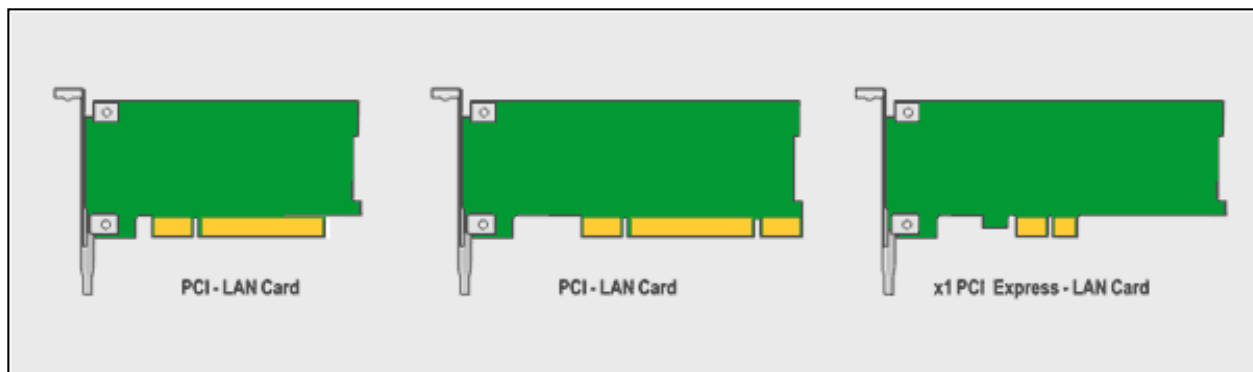
**Figure 4. Comparison of PCI Express and PCI Low-Profile Cards**

The differences between the PCI and PCI Express cards lie in their I/O connectors. A x1 PCI Express connector has 36 pins, compared to the 120 pins on a standard PCI connector.

Figure 4 (below) compares PCI and PCI Express low-profile cards. The x1 PCI Express connector shown is much smaller than the connector on the PCI card. Next to the PCI Express connector is a small tab that precludes it from being inserted into a PCI slot. The standard and low-profile form factors also support **x4**, **x8**, and **x16** implementations.

To date, Allen Bradley has not made any 1784PKTX PCI card to fit into any PCI Express slot. Their Rev A card will only fit into the legacy standard PCI slots; their Rev B card can fit into both legacy standard and new standard PCI slots.
