Tech Note 1029 Troubleshooting Platform X Exceeds Maximum Heartbeats Timeouts

Topic#: 002865 Created: March 2014

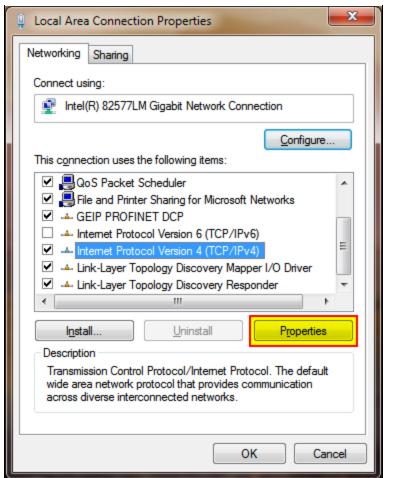
FIGURE 1: CLICK PROPERTIES TO SEE NIC PROPERTIES

Tech Note 916 presents troubleshooting guidelines for possible cause of NMX Hearbeat message. As briefly mentioned in item 19 of this technote, another possible cause of NMX Hearbeat message could be the fact that the NIC for the ArchestrA network could be configured to have multiple IP addresses. This is an advanced Windows TCP/IP setting (Figures 1-3 below).
