7S.43/63

7S SIL3 - IEC61508

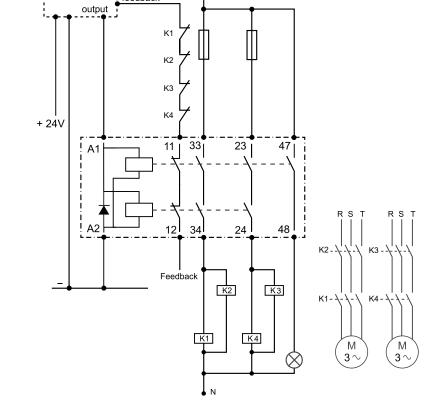
The data provided below refer to contacts NO 22-23, 33-34.

The NO contact 47-48 is an auxiliary contact for general use.

NO	23-24		
Safety Contacts		33-34	SIL3 evaluated according to IEC/EN 61508	
	NC	11-12	123,21101300	
Auxiliary Contact depending on 7S type	NO	47-48	Tested according to EN 61810-3
